INDOOR AIR QUALITY REASSESSMENT

**Crowell Elementary School
26 Belmont Avenue
Haverhill, Massachusetts 01830**

Prepared by:
Massachusetts Department of Public Health
Center for Environmental Health
Bureau Emergency Response/Indoor Air Quality Program
August 2005

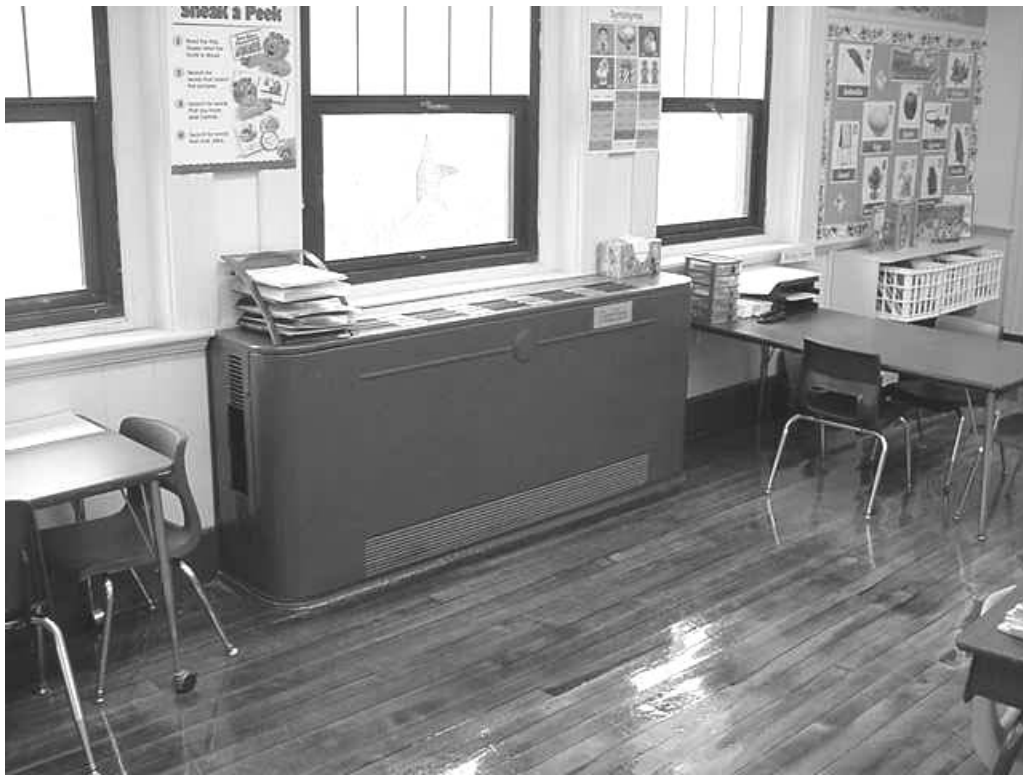
Picture 1

Fresh air in classrooms was originally supplied by a unit ventilator (univent) system (Picture 1). Univents are designed to draw air from outdoors through a fresh air intake located on the exterior walls of the building (Picture 2) and return air through an air intake located at the base of each unit ([Figure 1](#)). Obstructions to airflow, such as furniture located in front of and/or materials stored on univents seen during the original assessment, had been removed in most

classrooms. As discussed, univents were deactivated in all classrooms throughout the school. In order for univents to provide fresh air as designed, these units must remain activated and allowed to operate. Mr. Jeff Dill reported these univents were in the process of being repaired.

Classroom univent

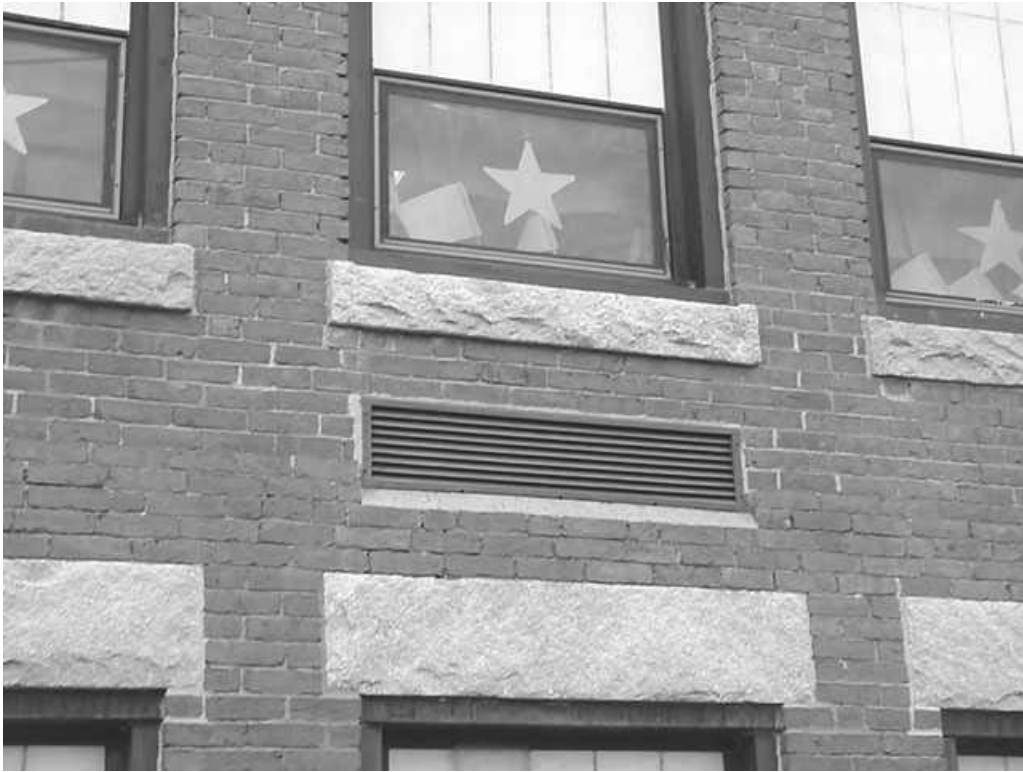
Picture 2

Exterior fresh air intake

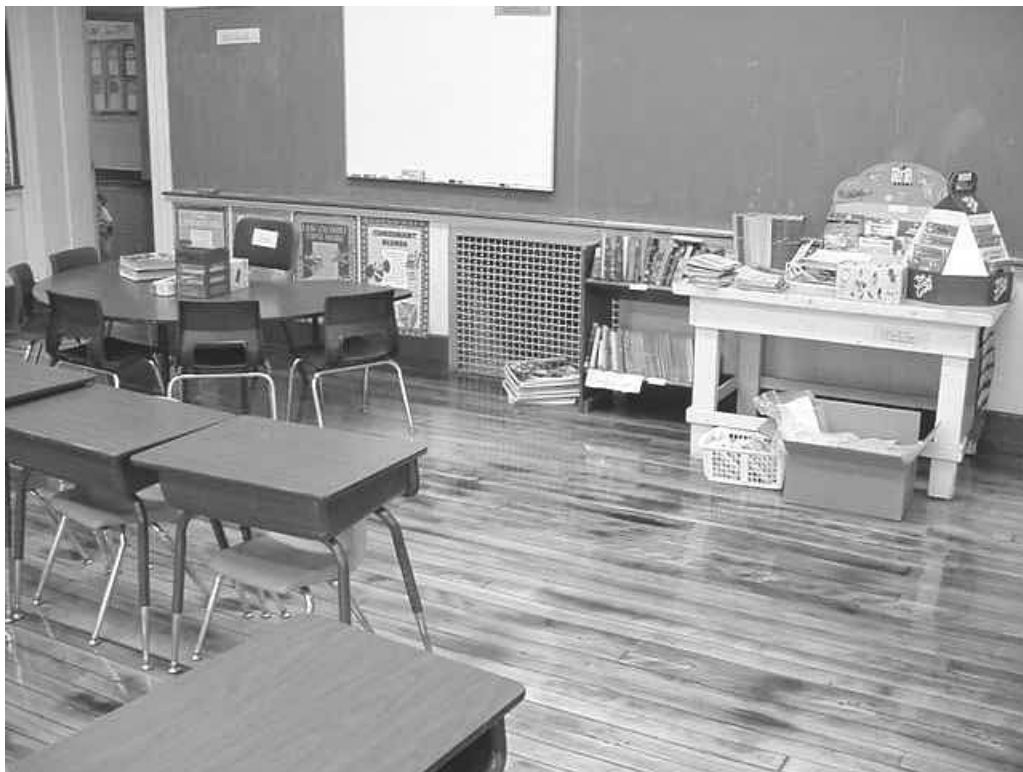
Picture 3

The exhaust ventilation system at the CES is reportedly atypical of a school building of its age. In the previous assessment, the ventilation system was described as a hybrid mechanical/gravity system, where the univent system was identified as the mechanical component and an interior vent system (Picture 3) identified as a gravity exhaust system. These observations were based on experiences from other indoor air quality assessments conducted in buildings of similar age. After a long discussion with Mr. Dill and a reexamination of the interior vents, it appears that the vents previously thought to be exhaust vents are actually heating vents connected to the building's furnace. The configuration of the heating system is as follows:

It appears that the classroom univents that provide tempered fresh air are the only functional mechanical ventilation components at the CES. No functioning exhaust vent system exists in the building. The sealed vents are actually artifacts of a previously existing heating system. The lack of an exhaust system coupled with deactivated univents would tend to result in an accumulation of indoor pollutants. Even with univents operating in the current configuration,

Grated heat supply vent

1. Examine the feasibility of providing a mechanical exhaust ventilation system for the building.
2. Use openable windows to create air exchange. Care should be taken to ensure windows are properly closed at night and weekends to avoid the freezing of pipes and potential flooding.
3. All ventilation systems that are operable throughout the building (e.g., gym, auditorium, classrooms) should operate continuously during periods of school occupancy and independent of thermostat control to maximize air exchange.

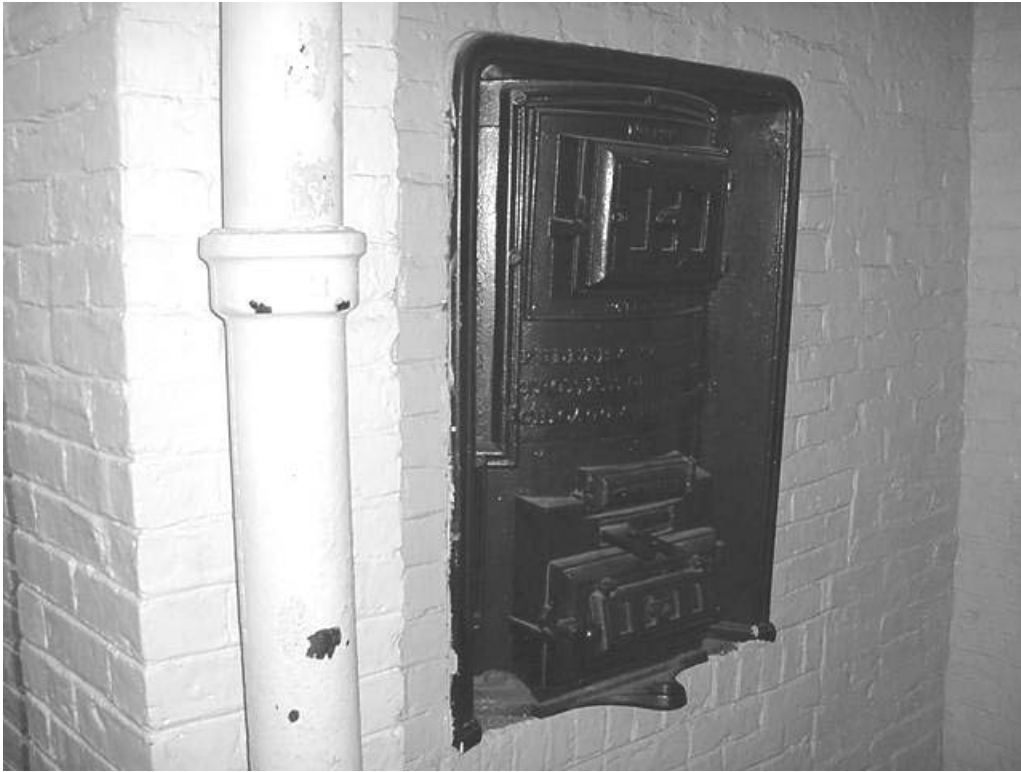
Picture 4

Further evaluation of a building component identified in the previous assessment (Picture 4) confirmed that it was a door for the school's abandoned incinerator. The structure would be connected to the chimney located on the eastern half of the CES, with the chimney above the western half servicing the furnace. For these reasons, it is unlikely that this structure would serve as a means for odors and particles to move into upper level areas of the building.

Incinerator Door Previously Identified as Dumbwaiter
